**MULTI-MEDIA COMPLIANCE EVALUATION INSPECTION
U.S. ENVIRONMENTAL PROTECTION AGENCY
REGION III
OFFICE OF ENFORCEMENT, COMPLIANCE, & ENVIRONMENTAL JUSTICE**

**American Zinc Recycling Corporation
(formerly Horsehead Corporation)
900 Delaware Ave
Palmerton, Pennsylvania 18071**

Inspection Dates: 14-18 May 2018

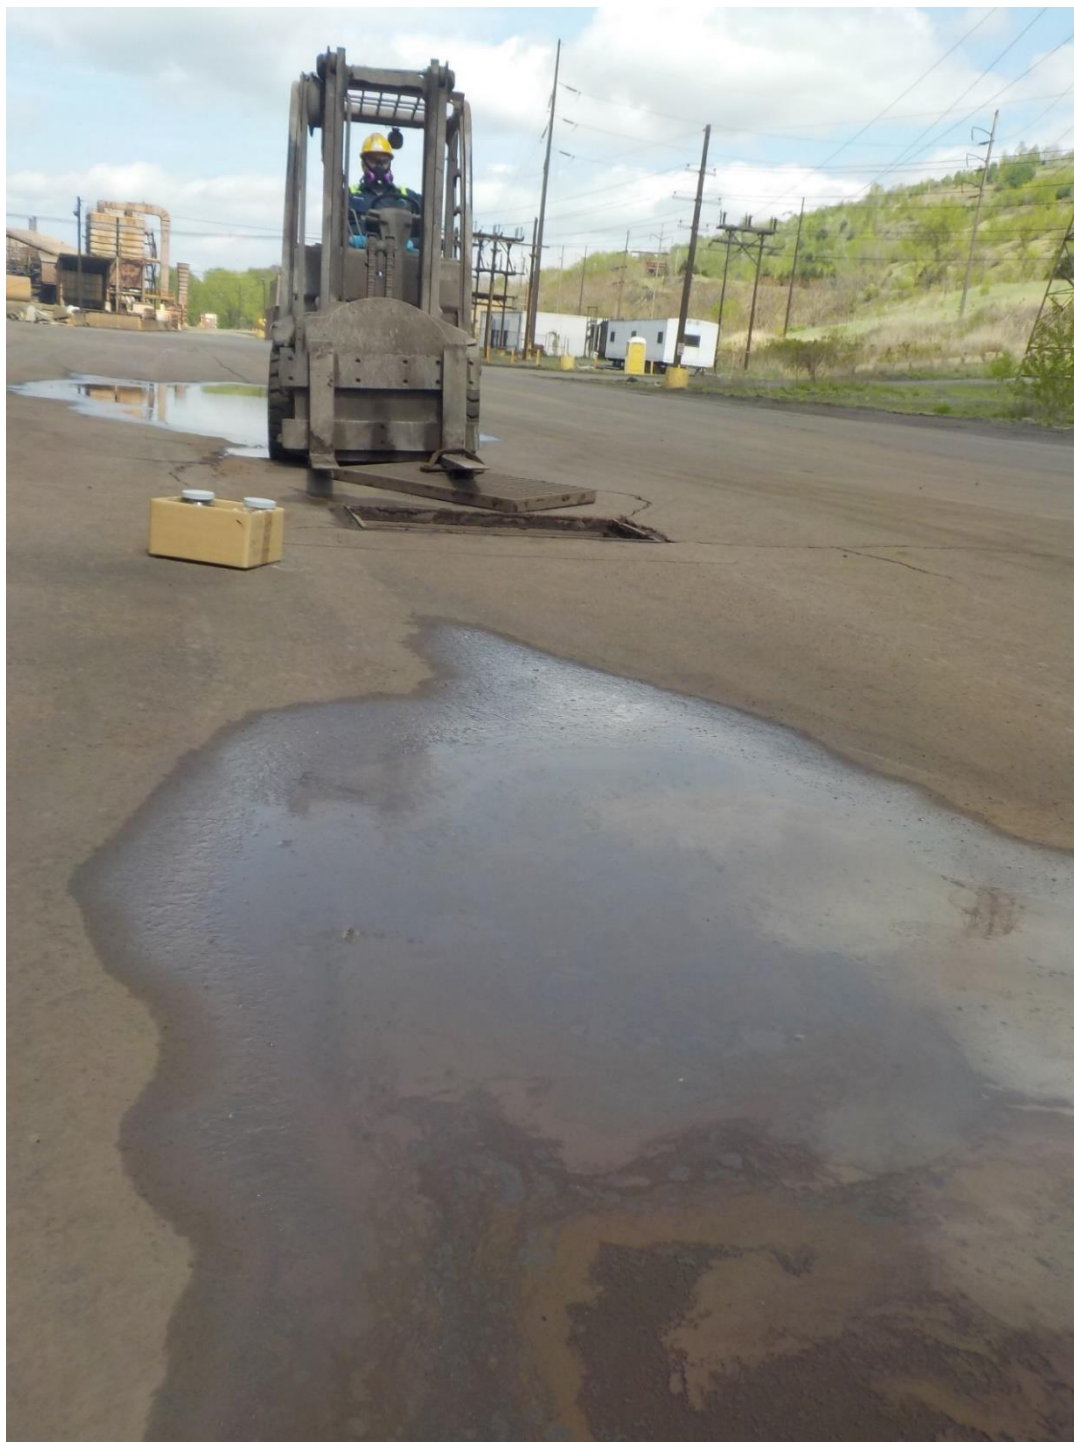
Photo 3. (DCSN0111) This photo, taken near the Building 608 truck entrance, looks east along the southern access road that runs along the southern boundary of the Facility. In this photo, a Facility employee with a forklift has removed the metal grate that covers the inlet to catch basin # 1 to allow sampling of the material in the bottom. Note, the eastern side of the storm water puddle in front of the Building 608 truck entrance is visible in the foreground.

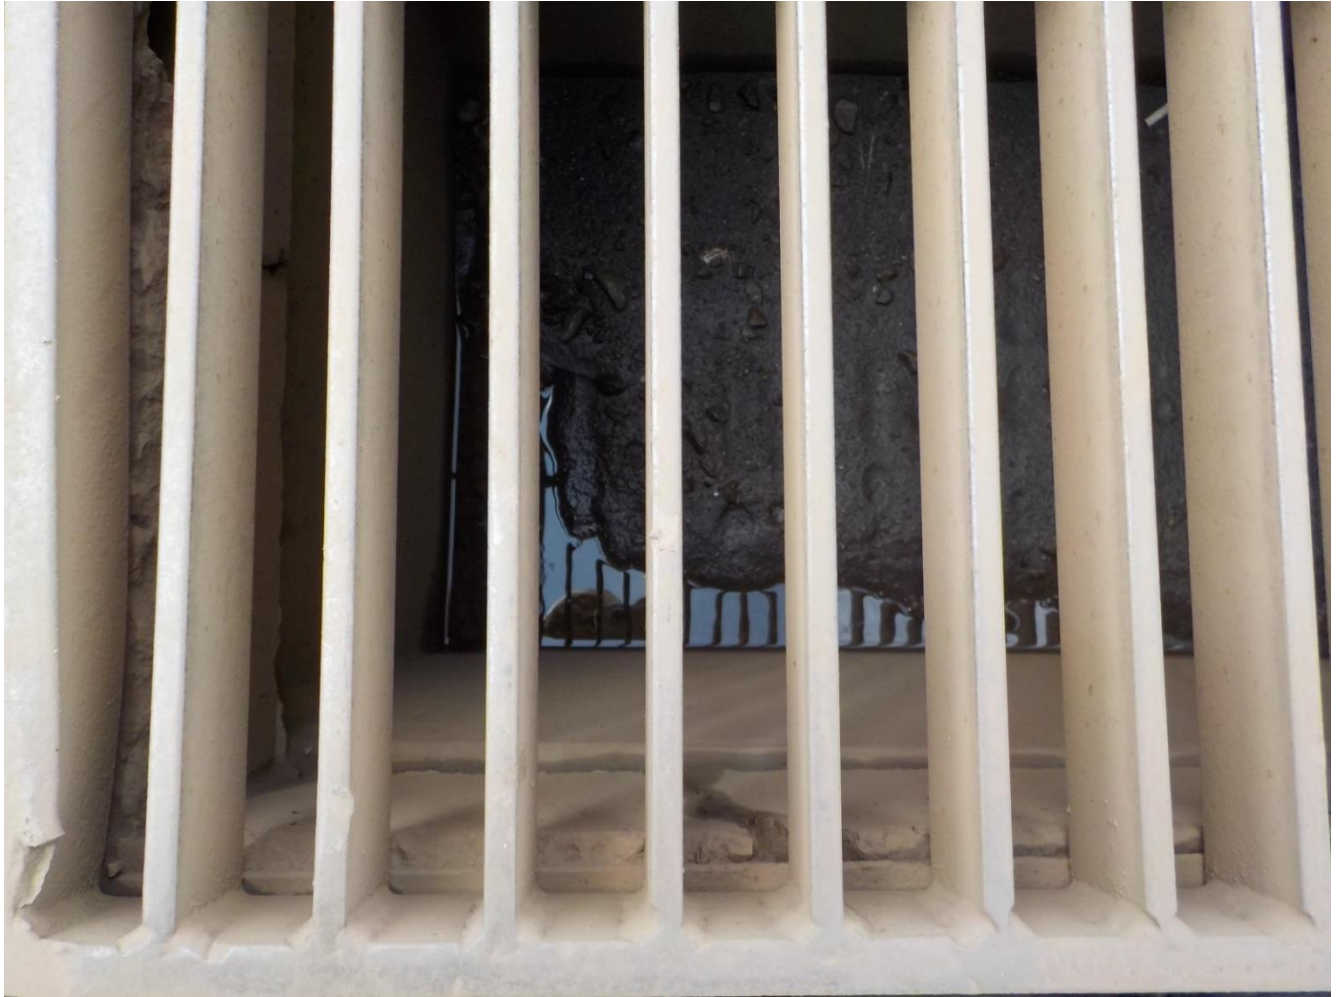
annotated in Figure 3. Each of these four catch basins connects to Lateral 5, which consists of a 21-inch diameter galvanized carbon steel pipe in this area that runs westward under the paved southern access road. Eller, Kline, and Trakis observed no physical storm water pollution prevention measures, (e.g. sediment filter fabrics) were present at catch basins #1, #2, #3, and #4. EPA inspectors Eller, Kline, and Trakis observed that a large, elongated puddle of water was present on the pavement approximately 3-5 meters (10-15 feet) from the south wall of building 608, in front of the truck entrance roll-up door (see Photo 8). The EPA inspectors note that the Palmerton area had received rainfall over the weekend previous to the Inspection on Saturday 12 May – Sunday 13 May, 2018 (see NOAA precipitation data in Table 1). The water in the puddle appeared cloudy and discolored with brown suspended sediment (see Photo 9). EPA inspectors Eller, Kline, and Trakis observed that wet, brown, fine-grained material, with some gravel-sized clasts or clumps entrained in the fine matrix, along with brown, cloudy water, was present in the bottom of catch basins #1, #2, #3 and #4 (see Photos 2, 4, 5, and 7, respectively).

Photo 4. (DSCN0089) This photo, shows a portion of the interior of catch basin #2, located southeast of the Building 608 truck entrance, offset from storm sewer lateral 5. Note the deposits of fine-grained, brown material in the bottom of the catch basin.

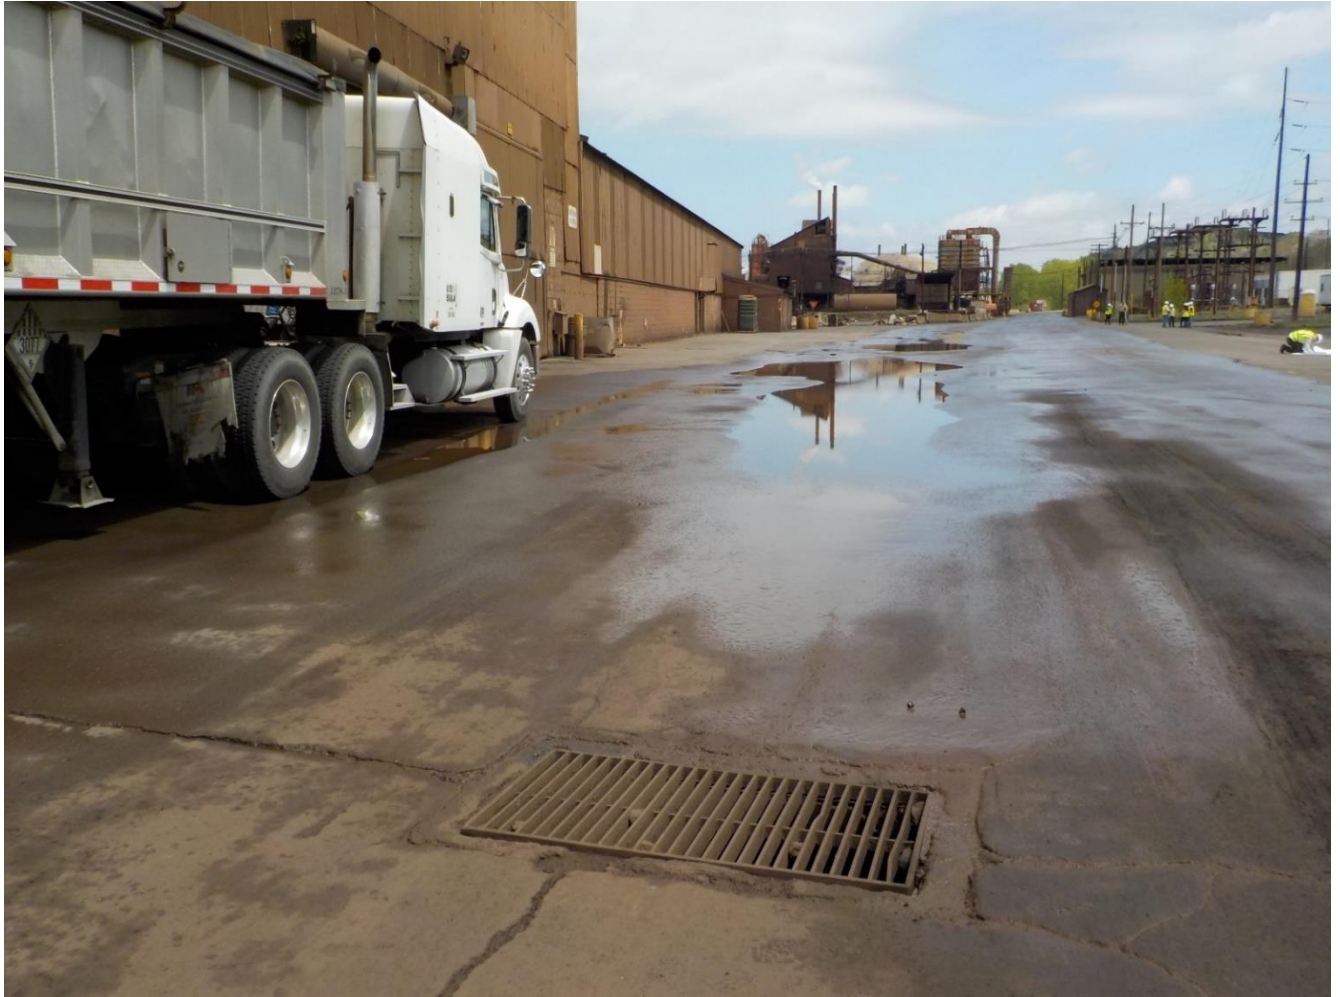
Photo 6. (DSCN0091) This photo just west of catch basin # 3, looks eastward along the southern access road that runs along the southern boundary of the Facility. At left, Building 608 and a truck delivering EAF dust is visible awaiting entrance. The metal inlet grate in the foreground is catch basin # 3. The puddle of storm water in front of the Building 608 truck entrance is visible in the middle ground of this photo.

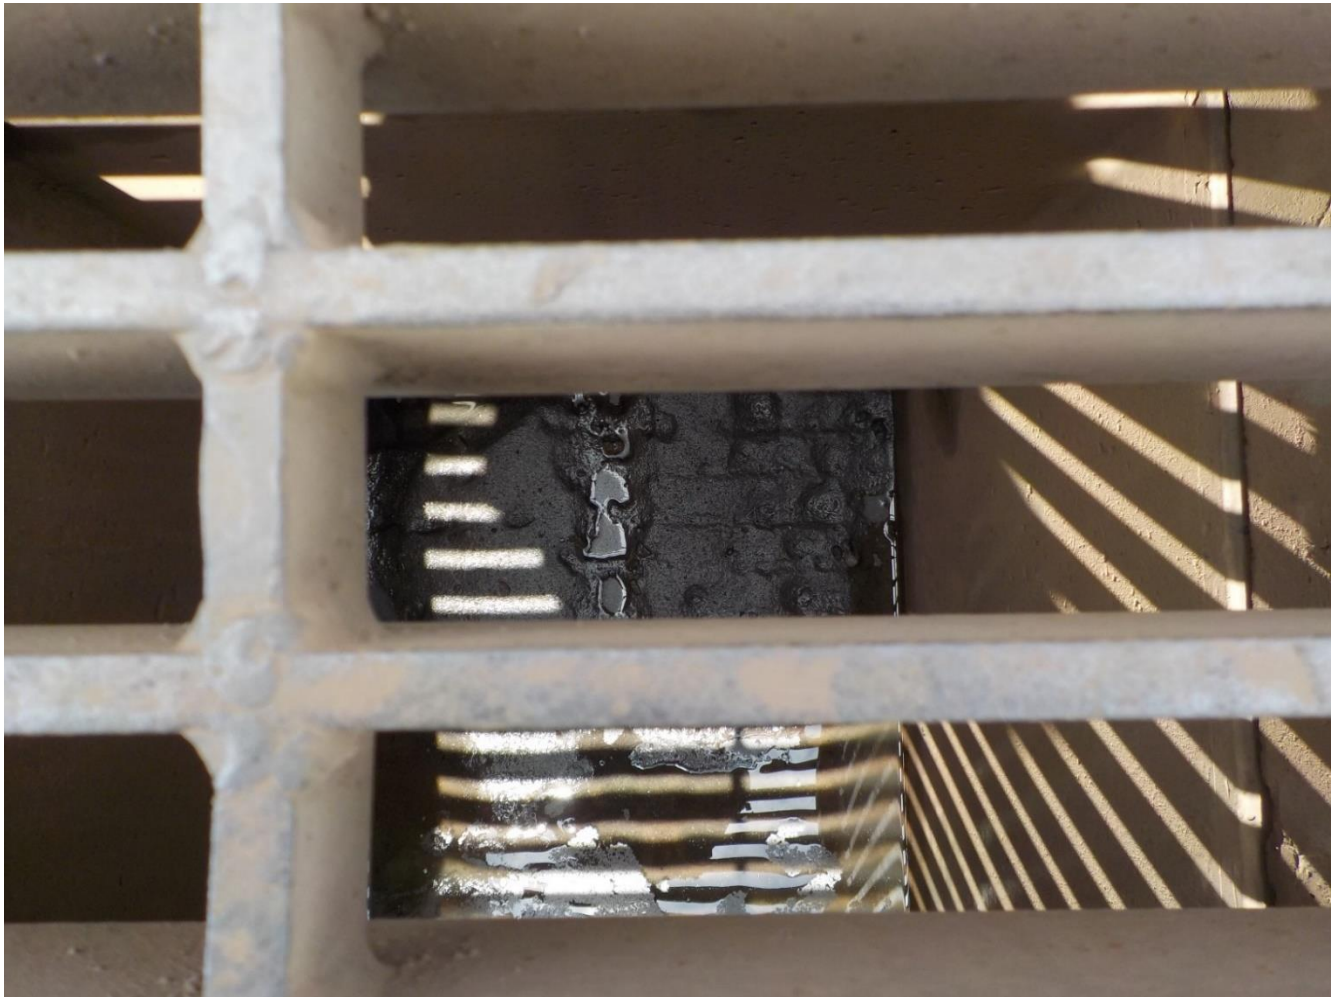
Photo 7. (DSCN0093) This photo shows a portion of the interior of catch basin #4, located SW of the Building 608 truck entrance, offset from storm sewer lateral 5. Note the deposits of fine-grained, brown material in the bottom of the catch basin.

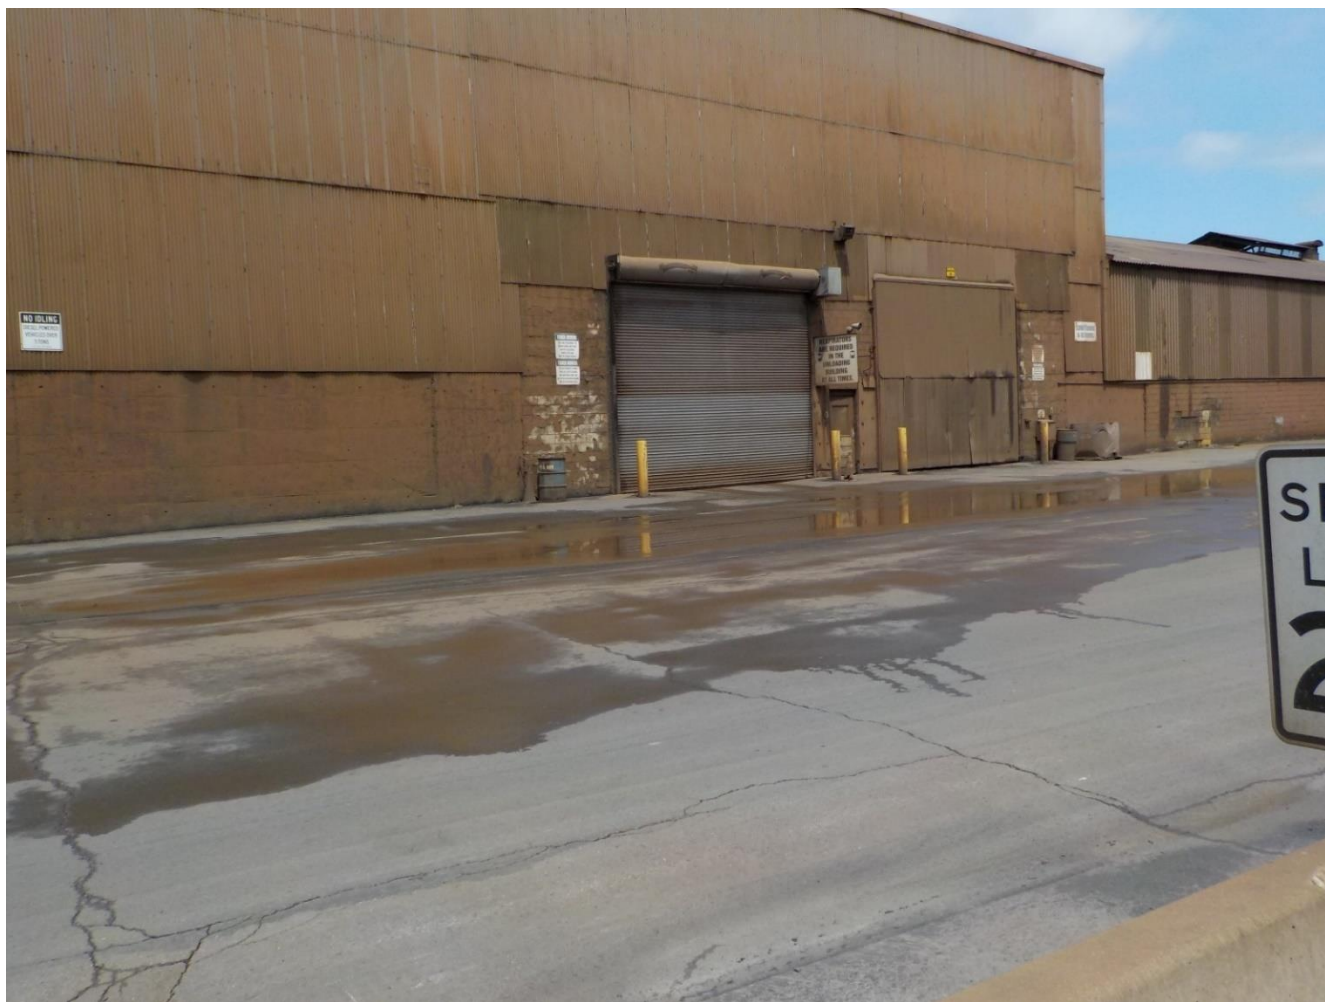
Photo 8. (DSCN0095) This photo, taken from a point along the southern perimeter of the Facility, looks northward towards the truck entrance on the south side of Building 608. A large puddle of storm water is visible on the paved road approximately 3-5 meters from the roll door. See also Photo 9 for a close-up view of water color, clarity, and suspended sediment.

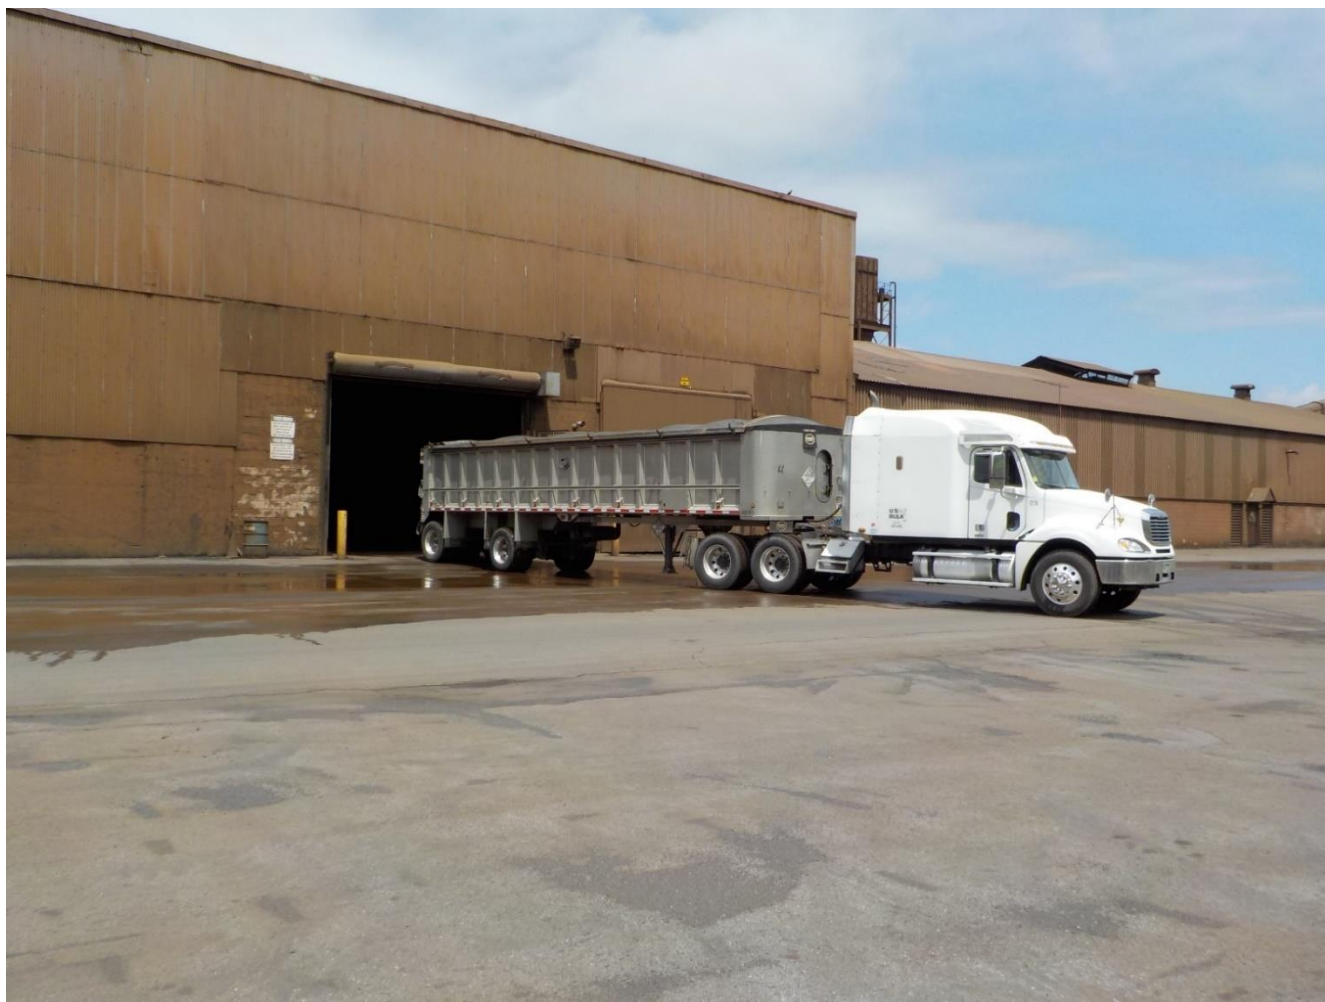
At approximately 12:57, the EPA inspectors observed a truck enter building 608 to make a delivery of EAF dust by backing through the open roll-up door (see Photo 10).

Photo 10. (DSCN0092) This photo shows a tractor-trailer truck backing through the Building 608 truck entrance to make a delivery of EAF dust.

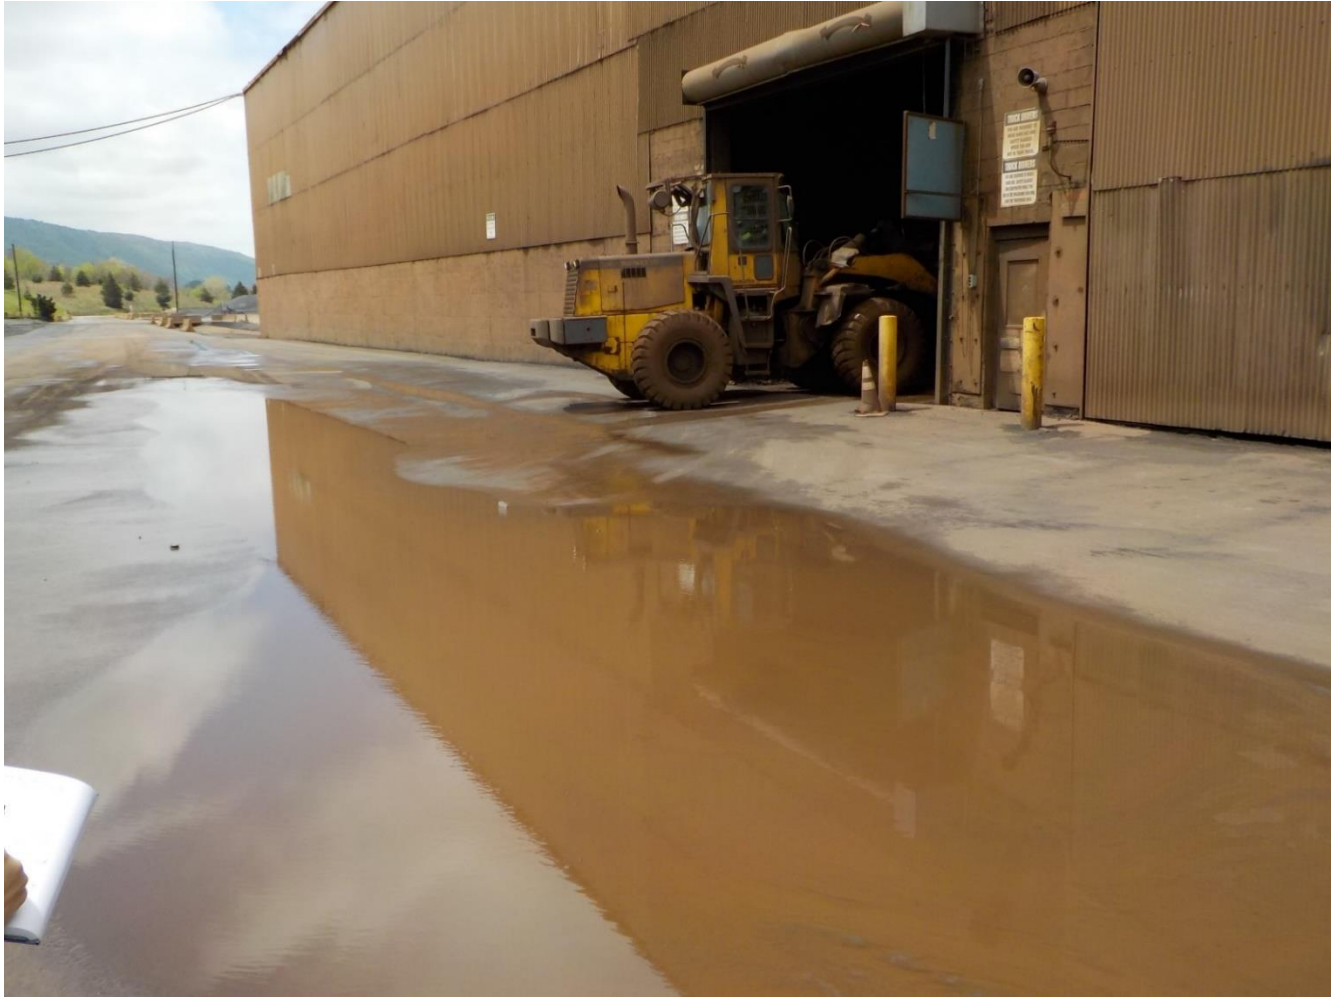
Photo 11. (DSCN0098) This photo taken from catch basin 1, looks westward towards the Building 608 truck entrance. A yellow payloader is visible backing out of the truck entrance. Note, there is wet, brown material on the payloader's tires, and streaks of wet, brown material on the pavement, extending from the door to the storm water puddle in the foreground.

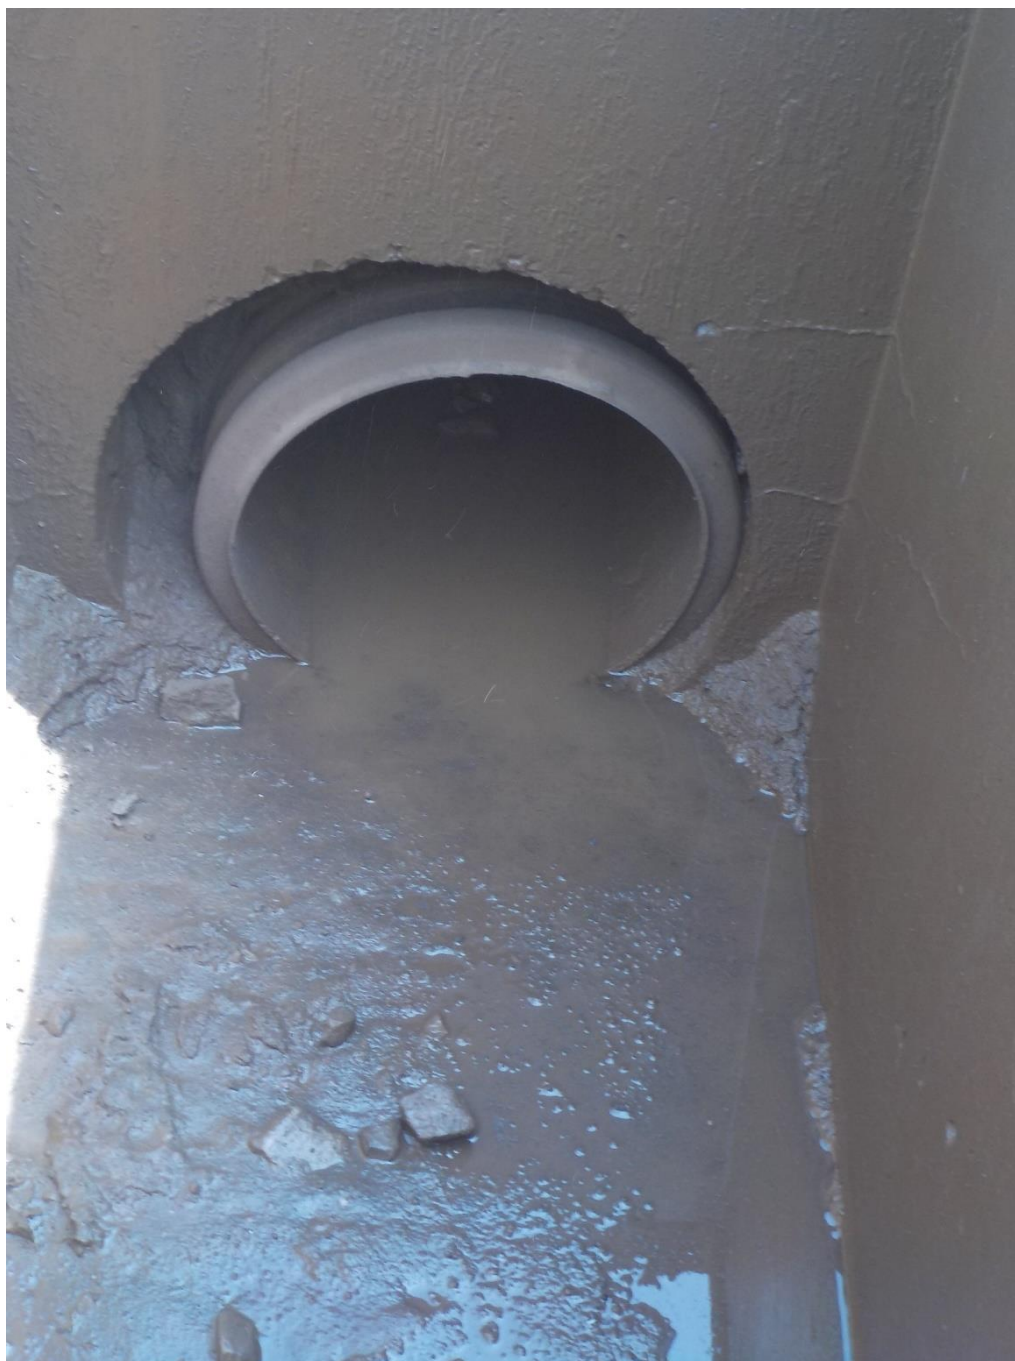
At approximately 14:15, the EPA inspectors requested that the Facility remove the metal grate covering the inlet to catch basin # 1, located approximately 10-12 meters (30 to 40 feet) to the east-southeast of the building 608 truck entrance. A Facility forklift lifted the metal grate covering catch basin #1 (see Photo 3). EPA inspectors Eller, Kline, and Trakis observed there was wet, brown, fine-grained material caked on the outer edges of the metal grate. Deposits of wet, brown, fine-grained material with some gravel-sized clasts or agglomerations entrained in the finer matrix, were present in the bottom of catch basin #1 along with some water laden with brown suspended sediment (see Photo 12). At 14:45, EPA inspectors Kline and Eller collected an incremental sample of this wet, brown, fine-grained material utilizing a clean, disposable plastic scoop affixed to the end of a pole. At Mr. Falko’s request, Eller and Kline also provided a split sample of the same material to the Facility. Facility employee Mr. David Kunkle was present for the sampling of the brown material and received the sample splits. EPA Inspector Kline probed the depth of the brown, fine-grained material by vertically pushing the end of a pry bar downwards through the layer of material until it made contact with the bottom of the catch basin. EPA inspectors Eller and Kline estimated that, based on the length of brown mud remaining on the pry bar when it was removed from the layer of brown material, approximately 10 to 12 inches of the material was present in the bottom of catch basin # 1 (see Photo 13).

Photo 12. (DSCN0105) This photo shows the interior of catch basin 1, located approximately 10-12 meters (30-40 feet) E-SE of the Building 608 truck entrance, after the metal inlet grating was removed. Note the deposits of brown, fine-grained material with larger clasts or agglomerations entrained, and brown, cloudy water.

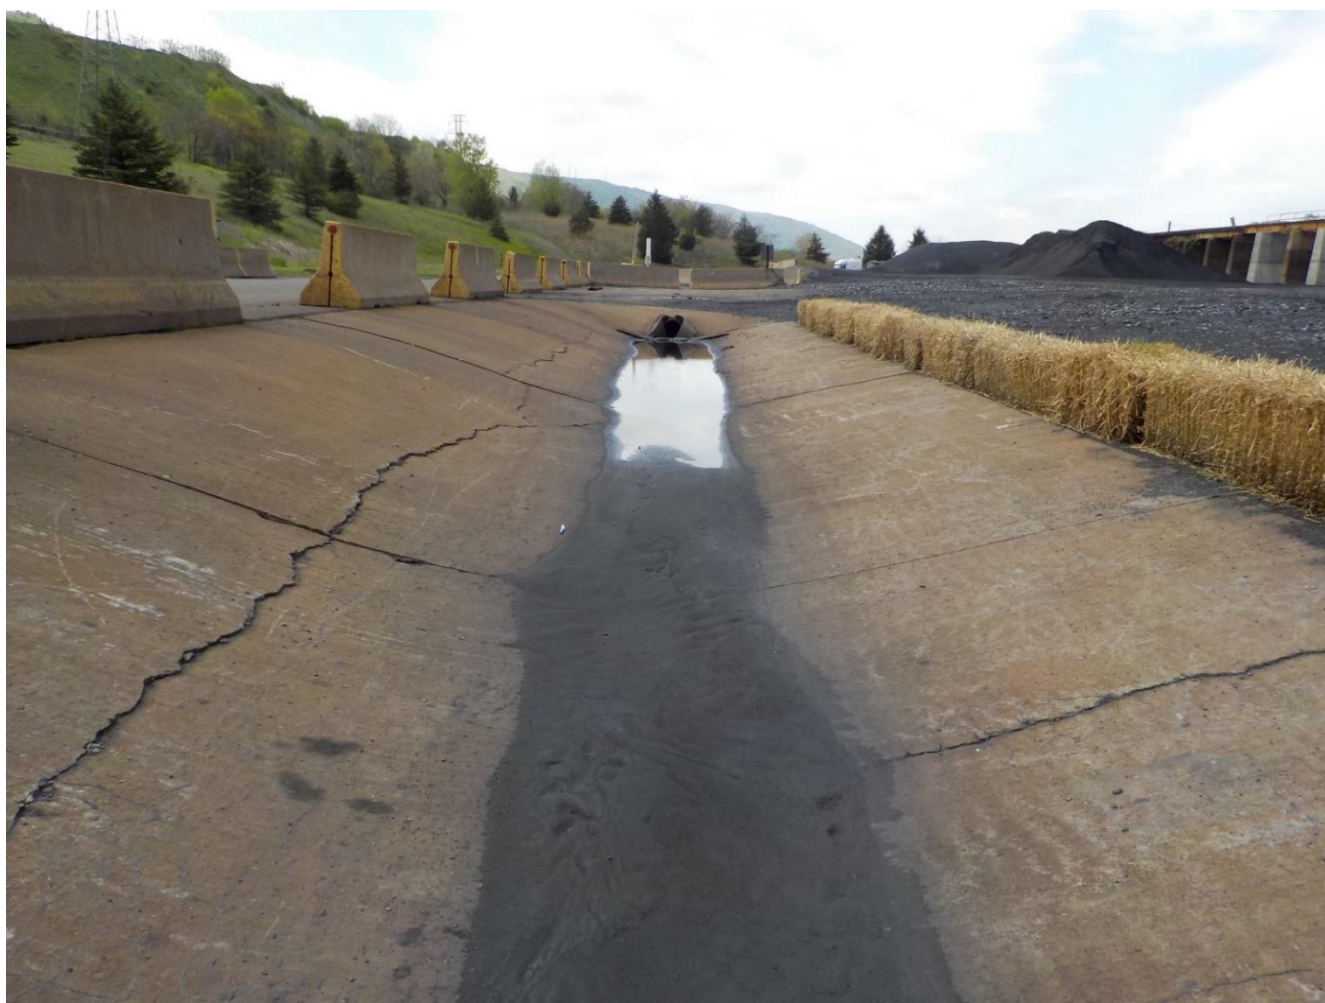
Photo 14. (DSCN0086) This photo looks westward along a concrete drainage swale parallel to the Facility's southern access road. Visible at right, in the distance, are uncovered piles of coke. Note the deposits of coke fines in the drainage swale.

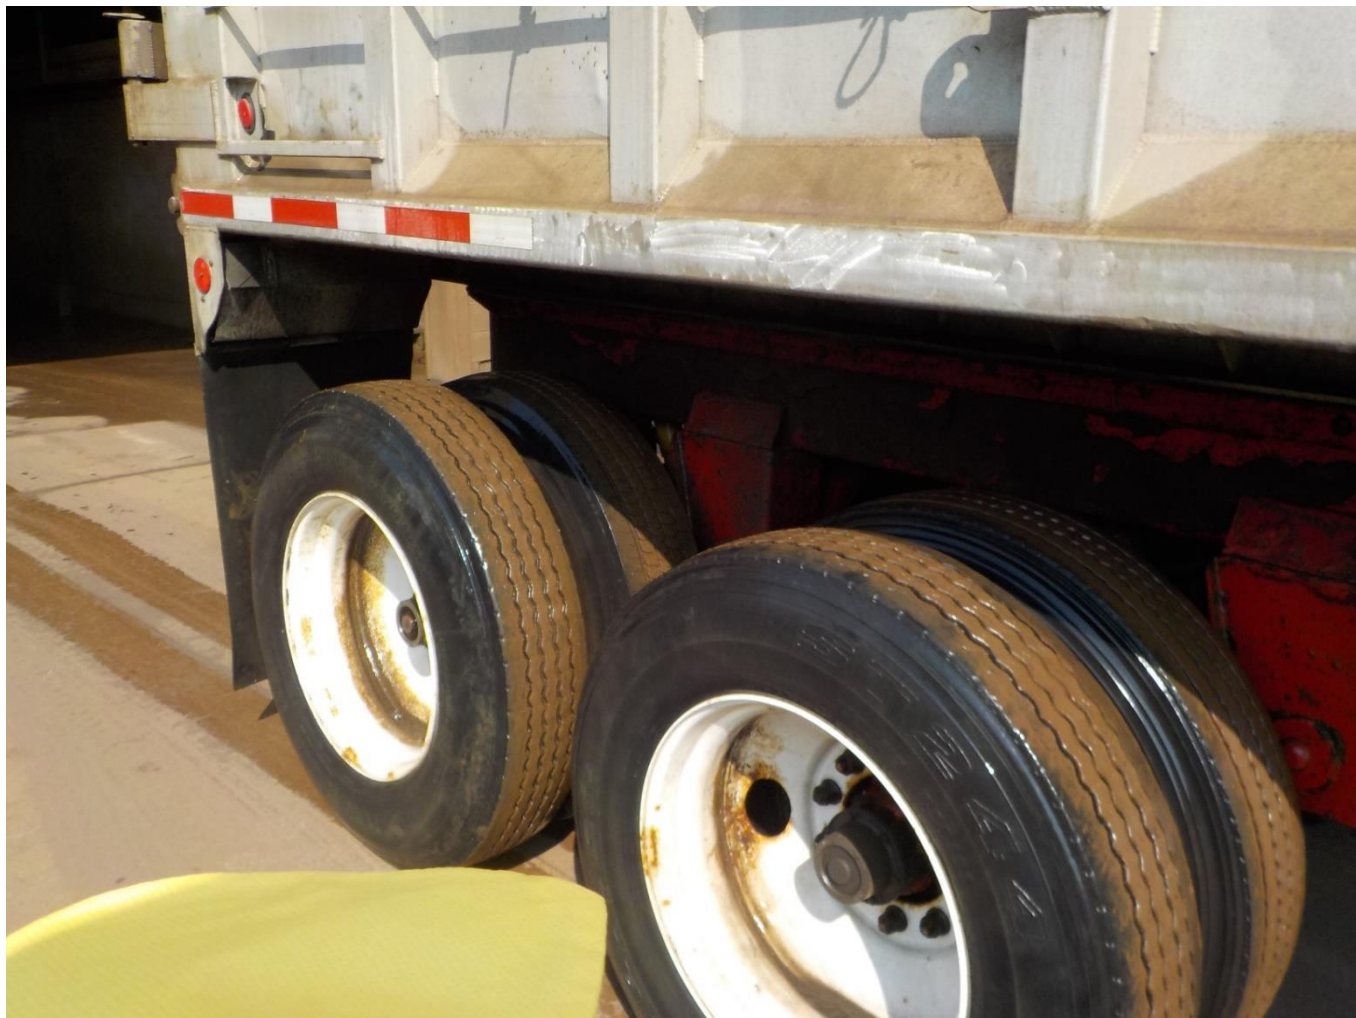
At 09:34 on 15 May, 2018, EPA inspectors Eller and Kline and PADEP representative Akers, donned air purifying respirators and entered building 608 via the truck wash bays (building 624), escorted by Facility representatives Mr. Falko and Mr. Kunkle. Immediately prior to entering the building, at 09:38, EPA inspectors Eller and Kline observed a tractor trailer truck exiting the truck wash bays (building 624). EPA inspectors Eller and Kline observed that the treads on the tires of the rear wheels of the vehicle appeared to be coated with a thin layer of wet, brown dust. EPA inspectors Eller and Kline observed that the tires left brown streaks on the exterior pavement as the truck exited the wash bay (see Photo 15).

Photo 15. (DSCN0117) This photo, taken outside the Building 624 truck wash exit doors, shows the rear tires of a truck exiting the truck wash bay after making a delivery of EAF dust in Building 608. Note the tires are coated with a thin layer of wet, brown dust. Note also the brown track-out marks on the pavement.

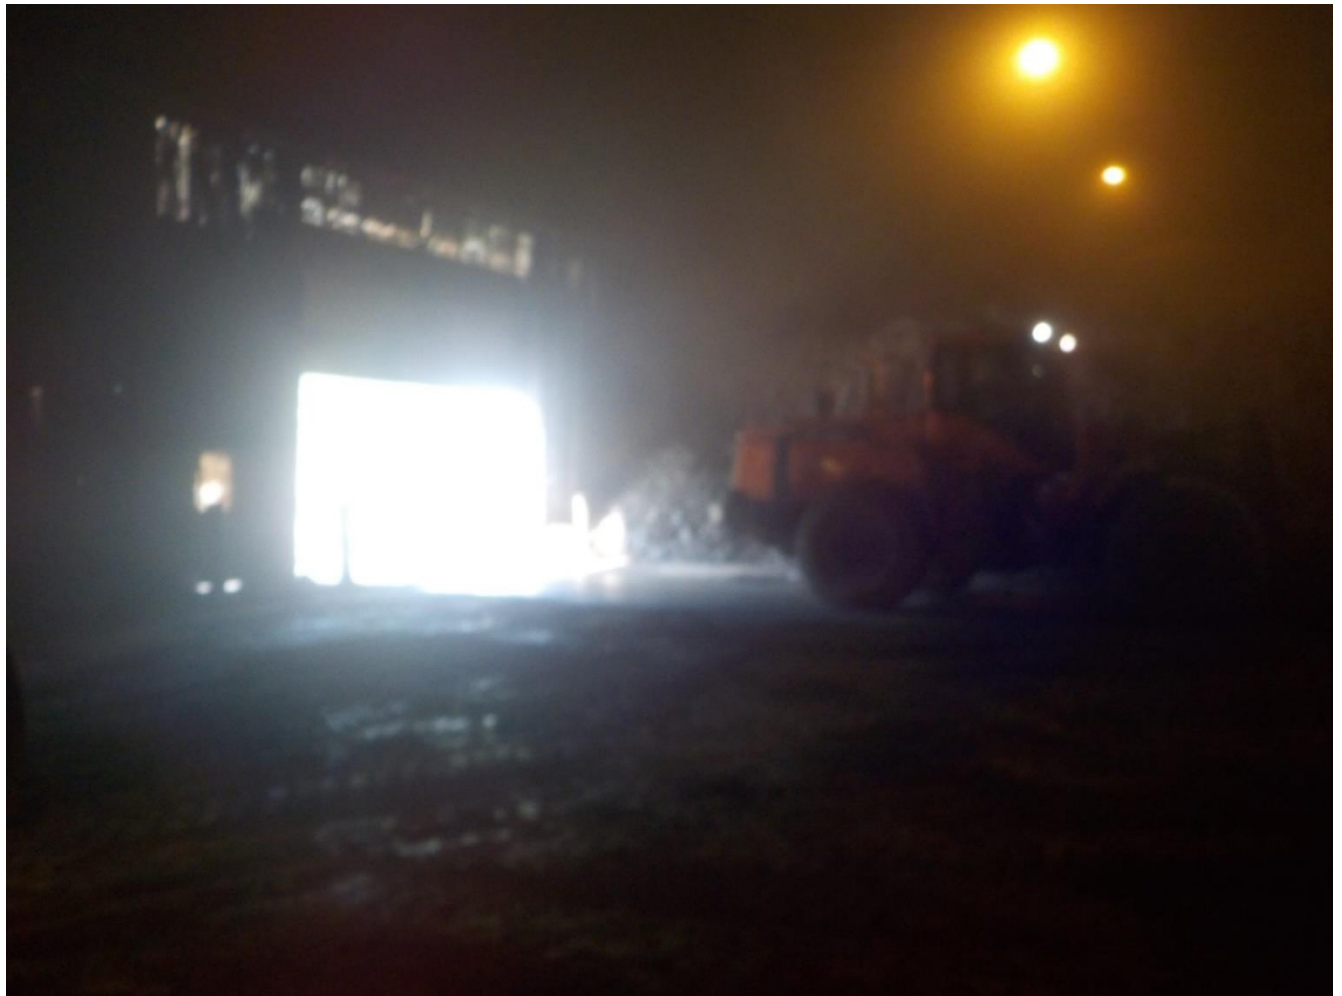
Photo 16. (DSCN0123) This photo shows part of the interior of Building 608, the RCRA-permitted storage building for EAF dust. Visible at right is a payload loader the Facility utilizes to manage EAF dust. The truck entrance roll-up door is open.

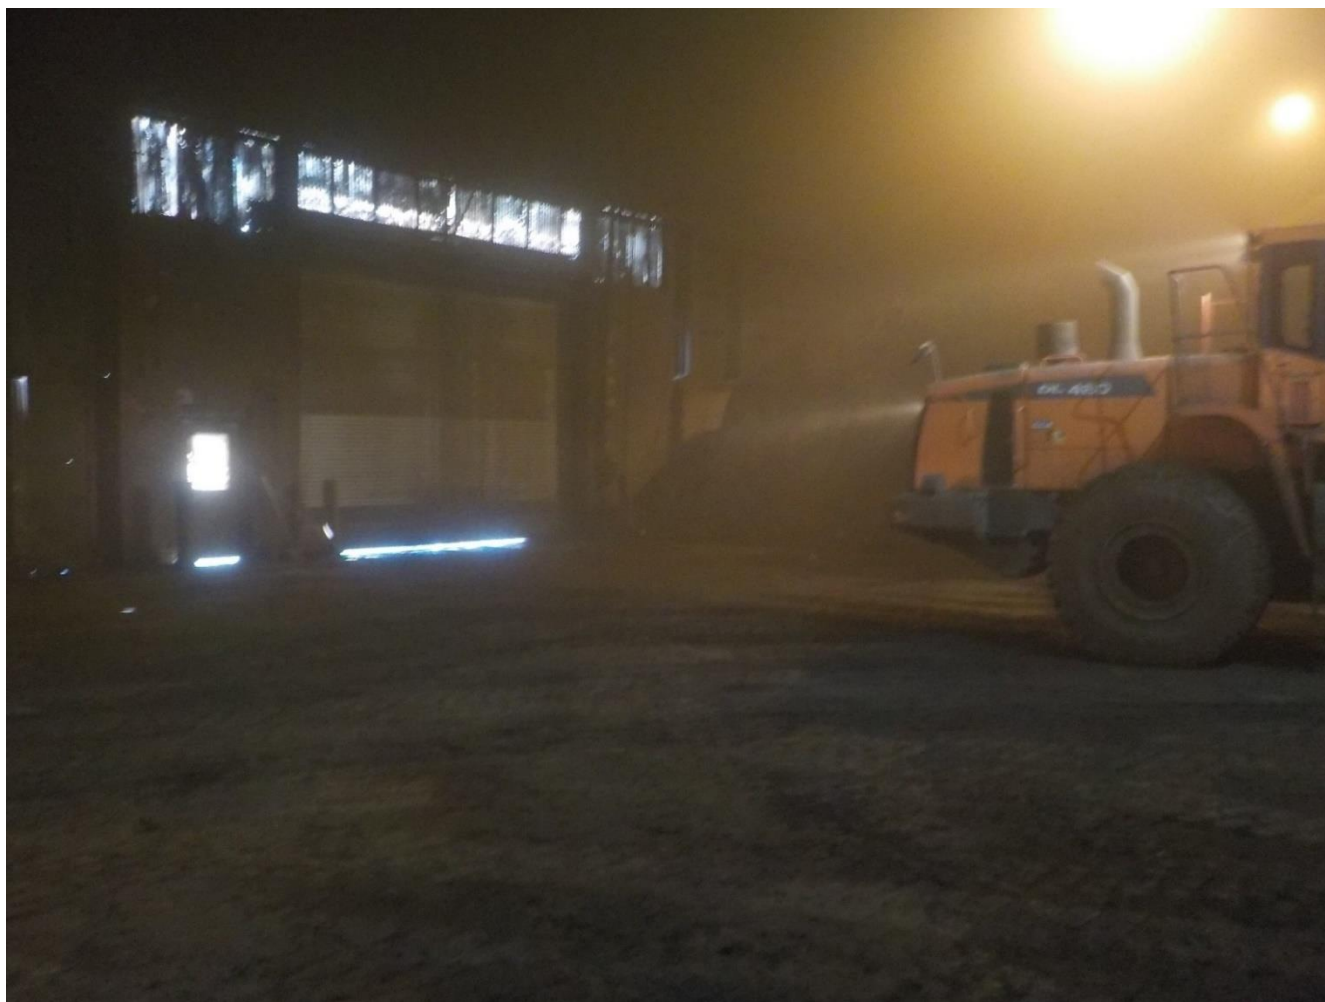
Eller and Kline observed a gap, which appeared to be approximately ½ inch and through which sunlight was visible, remained at the bottom of the roll-up door when it closed (see Photo 17). EPA inspectors Eller and Kline observed the operation of the payloader, pushing and consolidating EAF dust onto the main pile (see Photos 18, 19, 20, and 21) and a remotely-controlled water cannon wetting down the EAF dust. The roll-up door remained closed until approximately 09:49, when it opened again and a tractor trailer truck backed into the building. The roll-up door then closed again. EPA inspectors Eller and Kline then witnessed the tractor trailer dump its load of EAF dust, as well as the plastic liner from the trailer, onto the floor (see Photos 22 and 23). EPA inspectors Eller and Kline observed the remotely controlled water cannon spraying a water stream onto the newly-dumped EAF dust to wet it down, and that a puddle of standing water was present on the floor of building 608. EPA inspectors Eller and Kline then witnessed a payloader move the EAF dust that was just dumped by the truck and reconsolidate it onto the main EAF dust pile. EPA inspectors Eller and Kline did not observe any floor drains inside building 608.

Photo 17. (DSCN0125) This photo shows part of the interior of Building 608, the RCRA-permitted storage building for EAF dust. Visible at right is a payloader the Facility utilizes to manage EAF dust. The truck entrance roll-up door is closed. Note that daylight is visible through a gap at the bottom of the door.

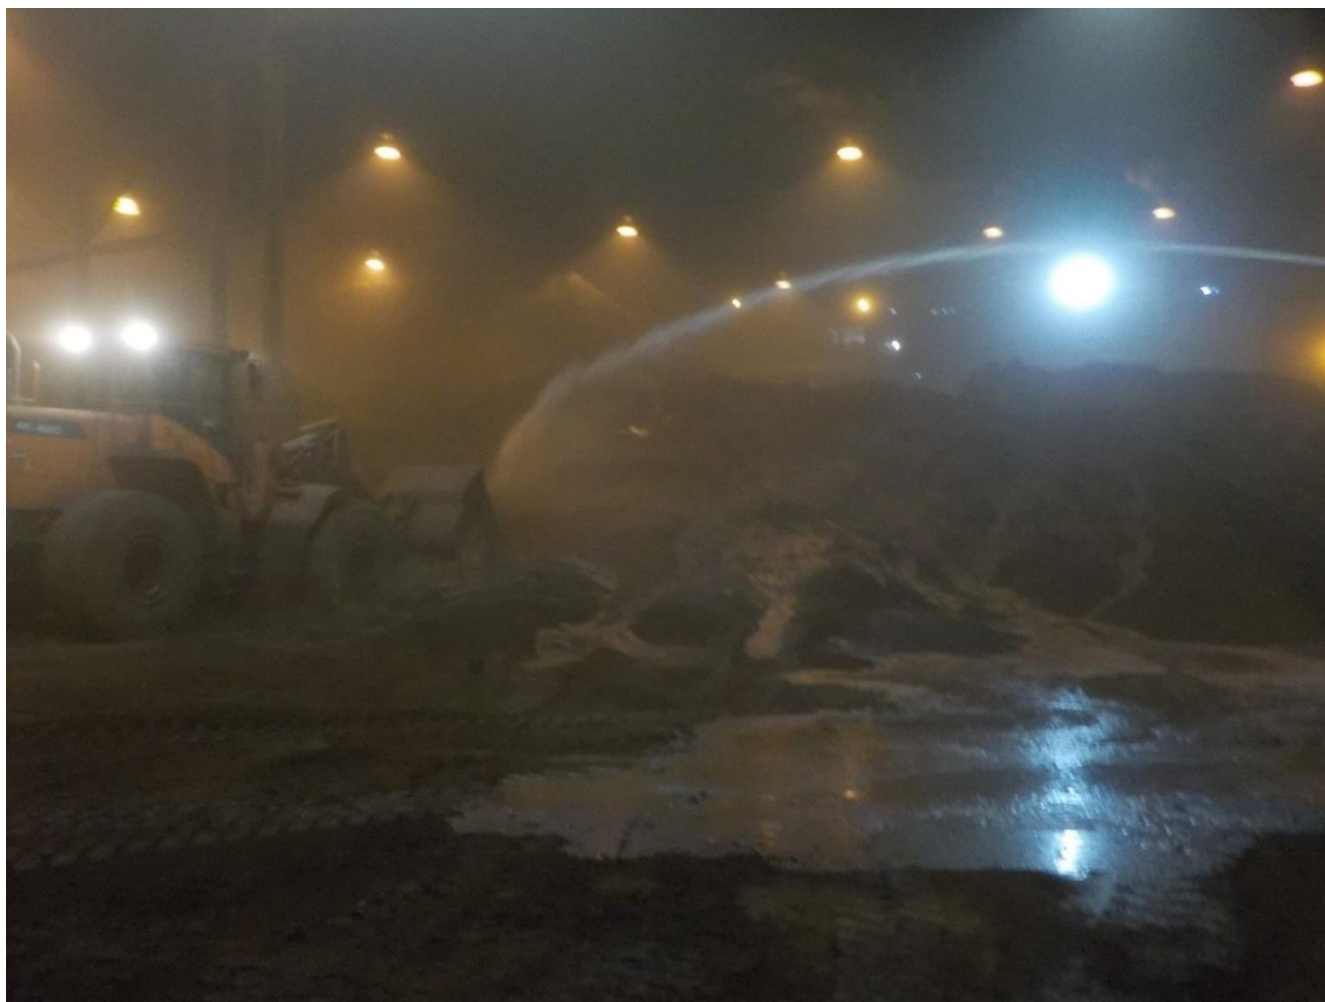
Photo 18. (DSCN0127) This photo shows part of the interior of Building 608, the RCRA-permitted storage building. Here, a payloador pushes a load of EAF dust onto the main EAF dust pile, visible in the background. A stream of water from a water cannon is visible arcing through this photo to wet down the EAF dust. Note the puddle of water is accumulating at right. See also Photo 19, 20, and 21.

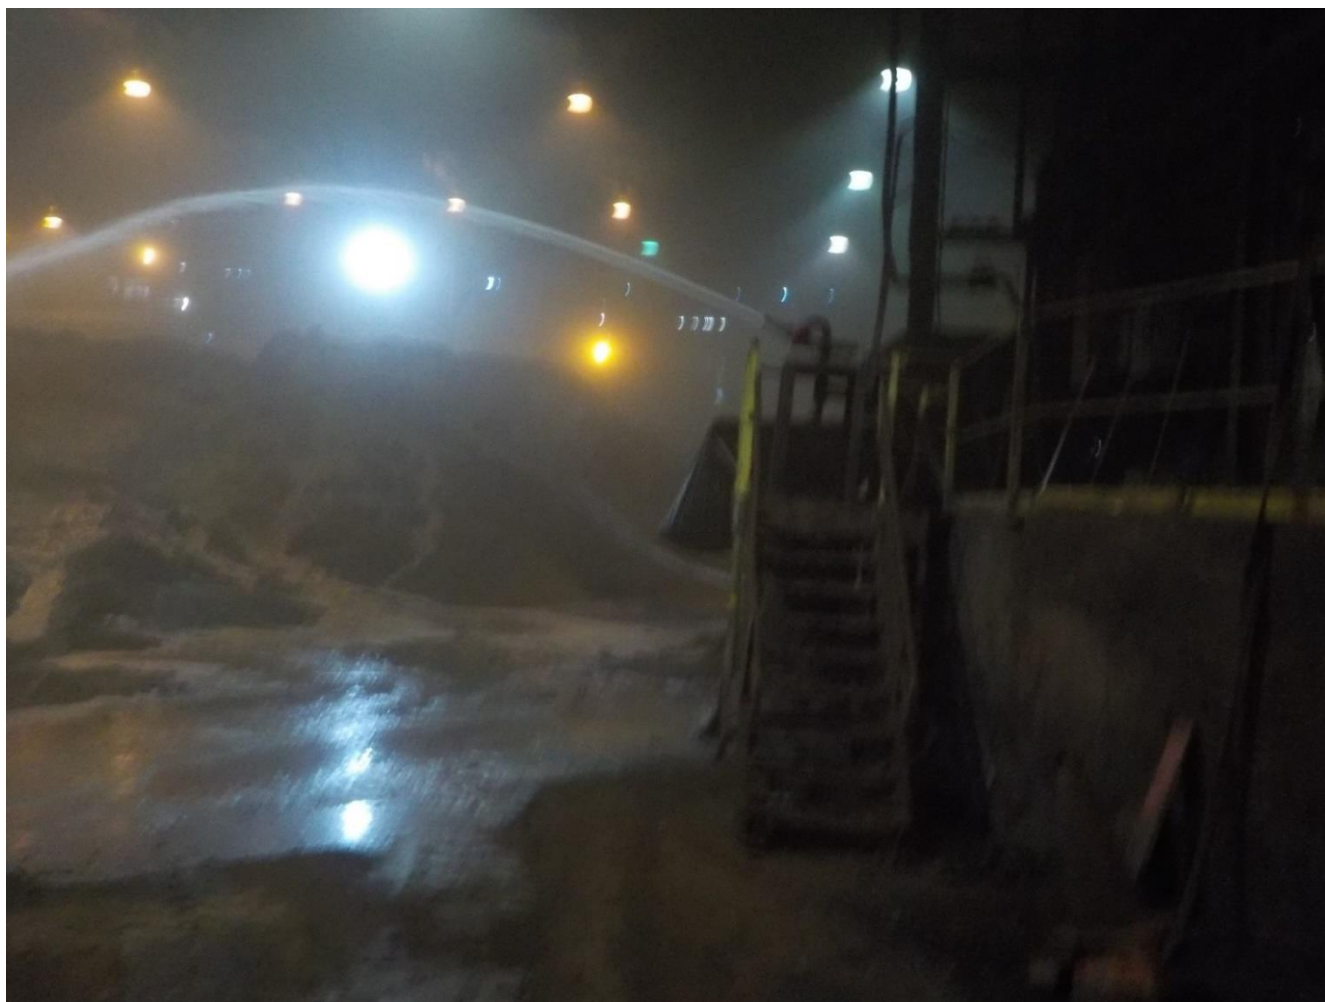
Photo 19. (DSCN0128) This photo shows another portion of the interior of Building 608, the RCRA-permitted storage building. The EAF dust main pile is visible at left in the background. At right, the stairs to the control booth and the water cannon are visible. The water cannon is emitting a stream of water to wet down EAF dust. See also Photo 18, 20, and 21.

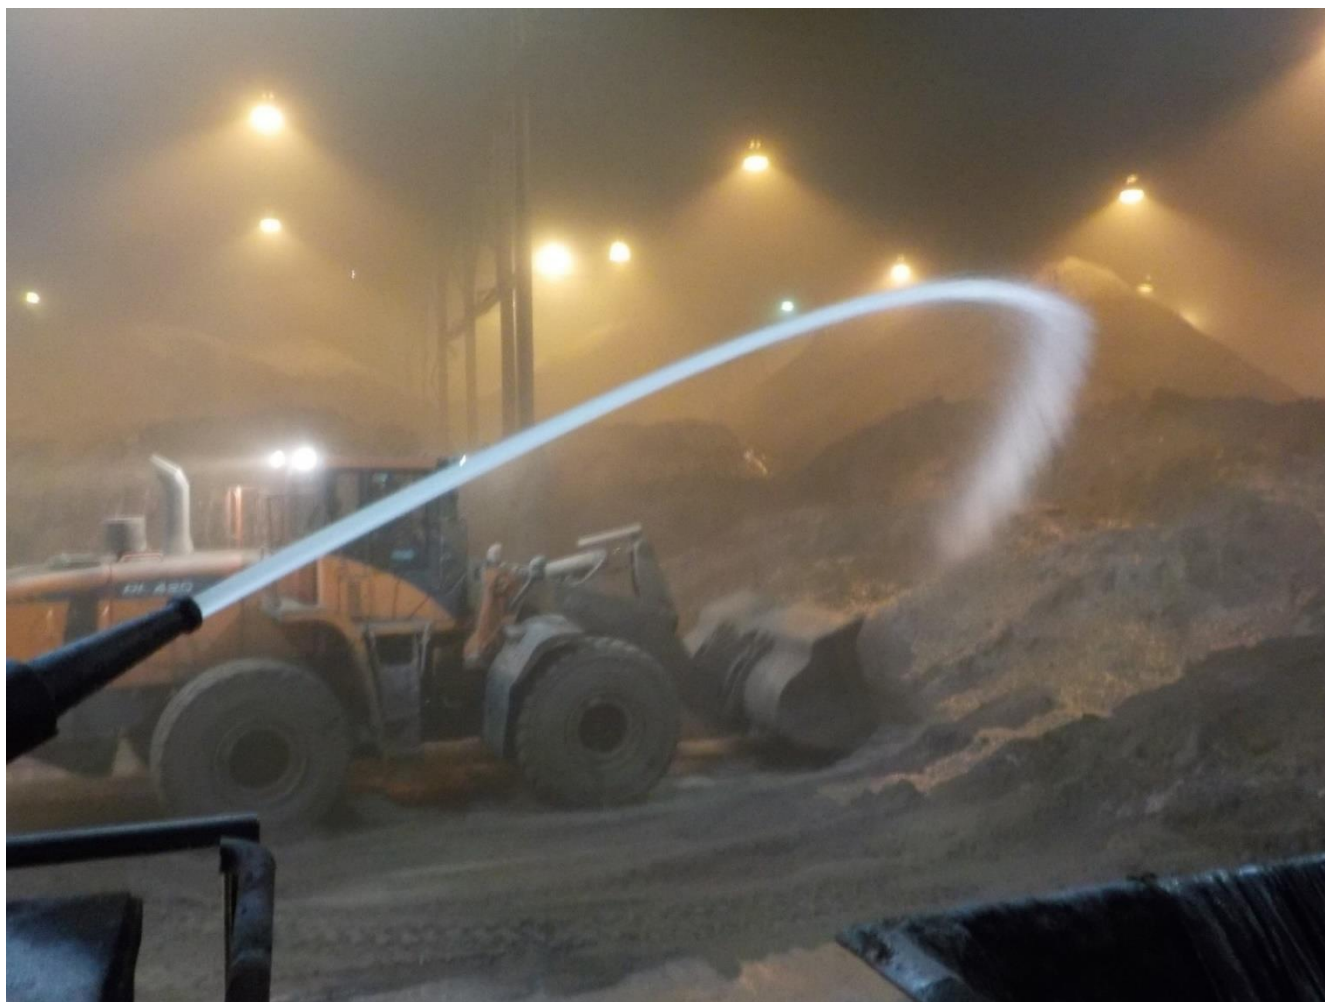
Photo 20. (DSCN0134) This photo shows a payloader pushing EAF dust onto the main EAF dust pile inside Building 608. The nozzle of the water cannon is visible at left, emitting a stream of water to wet down the dust. See also Photos 18, 19, and 21.
